SERVICE BULLETIN

BUCIE AMERICAN MOTORCYCLES

B-024B

SAFETY RECALL CODE 0817 - REVISED SHOCK EYE

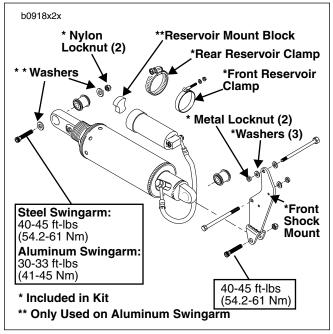
Figure 2. New Shock Absorber Assembly

The new front shock mount MUST be used with the new shock absorber. The new shock is 1.77 in. (45 mm) shorter than the previous shocks and requires the new front mount to align and install properly.

- See Figure 2. Use a flex socket and extension to remove locknut and washer on front reservoir clamp. Discard clamp, locknut and washer.
- See Figure 2. Loosen rear reservoir clamp. Slide reservoir and mount block out of clamp. Remove and discard clamp and mount block.

- See Figure 2. Install new front shock mount to crankcase with two new front shock mount bolts, washers, star washer (on 1997 M2, S3/S3T models only) and metal locknuts. Tighten bolts to 30-33 ft-lbs (41-45 Nm). NOTE: Top bolt goes in from the left side, bottom bolt goes in from right side. Bottom bolt does not use washer under bolt head. Star washer (only used on 1997 M2, S3/S3T models) goes on bottom bolt under the washer on the nut side. If exhaust was loosened during front shock mount removal, replace exhaust gaskets and reinstall exhaust. See appropriate Service Manual, Section 2 for instructions.

- See Figure 2. Position new shock absorber from kit in mounting position.
- 5. Loosely install bolt, washers (aluminum swingarms only) and **new** locknut through rear shock eye and swing arm.
- 6. Loosely install bolt and **new** locknut through front shock eye and front shock mount.
- On 1996-1998 vehicles only: Loosen header tie bar from collector.
- Position front clamp over reservoir. Loosely install new front reservoir clamp to front shock mount (and install new header tie bar spacer between front shock mount and header tie bar on 1996-98 vehicles only) with new washer and new nylon locknut.
- See Figure 3. Loosely install new rear clamp around reservoir and oil feed line.
- All Models: Install new reservoir mount block between oil pump fitting and remote reservoir.
