SERVICE BULLETIN **Buell**[®]

B-033A

December 4, 2000

SAFETY RECALL CODE 0820 - NEW SHOCK ABSORBER

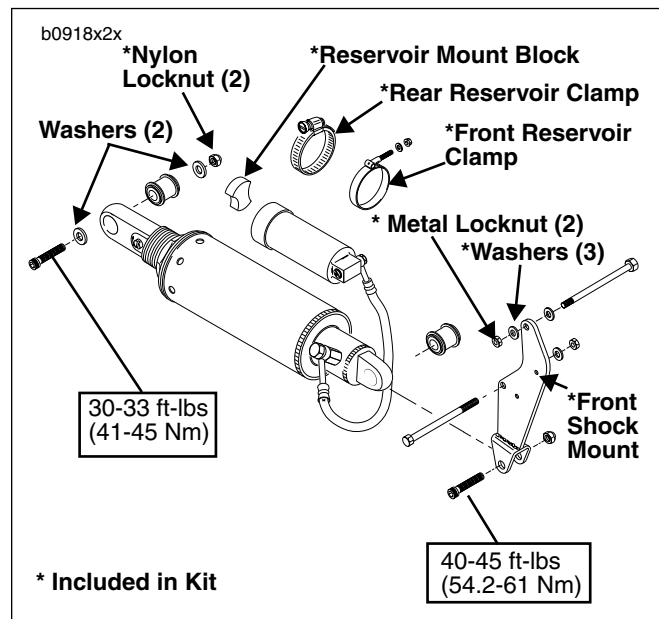
Figure 2. New Shock Absorber Assembly

The new front shock mount **MUST** be used with the new shock absorber. The new shock is 1.77 in. (45 mm) shorter than the previous shocks and requires the new front mount to align and install properly.

5. See Figure 2. Use a flex socket and extension to remove locknut and washer from front reservoir clamp. Discard clamp and locknut. Retain washer.
6. See Figure 2. Loosen rear reservoir clamp. Slide reservoir and mount block out of clamp. Remove and discard clamp and mount block.
7. Remove allen screw and locknut (metric) from front of shock and front shock mount. Discard locknut.
8. Remove allen screw, washers and locknut (metric) from rear of shock and swingarm while supporting shock absorber. Discard locknut. Retain washers for re-use.
9. Remove and discard shock absorber assembly.
10. Remove two screws, washers and voltage regulator from bracket.
11. Remove small button head screw and metal locknut (if present) that secures voltage regulator bracket to front shock mount. Leave bracket in place. Discard screw and metal locknut.

1. See Figure 2. Install new front shock mount to crankcase with two **new** front shock mount bolts, washers and metal locknuts. Tighten bolts to 30-33 ft-lbs (41-45 Nm). NOTE: Top bolt goes in from the left side, bottom bolt goes in from right side. The bottom bolt does not use washer under the bolt head.

4. See Figure 2. Position **new** shock absorber from kit in mounting position.
5. Loosely install bolt, washers and **new** locknut through rear shock eye and swing arm.
